NATIONAL PHOTOGRAPHIC INTERPRETATION CENTER

**TRANSSHIPMENT AND STORAGE AREAS
BAI DUC THON, NORTH VIETNAM
18-02N 105-50E**

ATTACHMENT TO M-5827
14 FEBRUARY 1969
PAGE 1

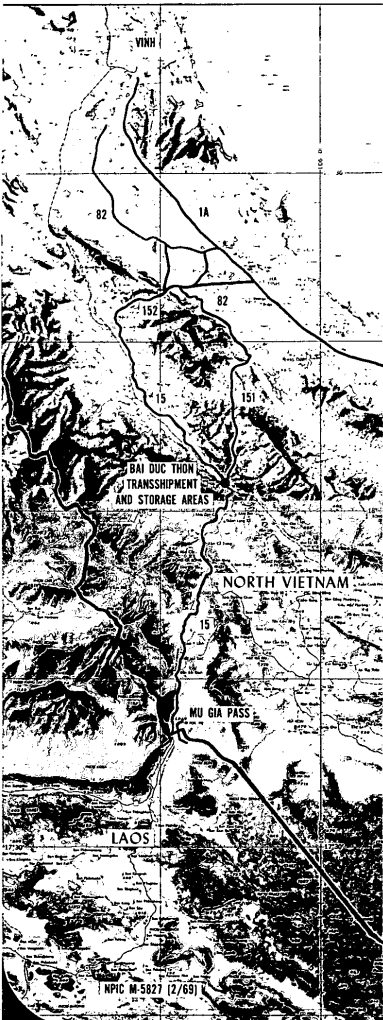
PHOTOGRAPHY OF 20 JANUARY 1969 REVEALS RAIL-TO-ROAD TRANSSHIPMENT AND TEMPORARY STORAGE OF SUPPLIES IN SEVERAL STORAGE AREAS ALONG THE RAIL LINE SERVING THE BAI DUC THON STAGING COMPLEX.

ON THE TOP PHOTO A LORRY TRAIN LOADED WITH POL DRUMS AND PROBABLE PETROLEUM PIPE IS OBSERVED STANDING ON A RAIL SIDING. HUTS/SHELTERS ALONG BOTH SIDES OF THE LINE ARE PROBABLY USED FOR SUPPLY STORAGE. SUPPLIES OBSERVED IN THE AREA OF THIS TRANSSHIPMENT POINT INCLUDES SACKED GOODS (PROBABLY RICE), POL DRUMS, AND STACKS OF CRATED GOODS.

THE CENTER PHOTO SHOWS POL DRUM STORAGE AND TRANSFER POINT LOCATED BETWEEN ROUTE 15 AND THE RAIL LINE. IN THE ENTIRE STAGING COMPLEX ON THIS DATE AT LEAST 2300 DRUMS (126,500 U.S. GAL CAPACITY) WERE OBSERVED. TWELVE STACKS OF PROBABLE PETROLEUM PIPES ARE ALSO SHOWN. THIS AREA IS APPARENTLY THE PRIMARY LOCATION OF RAIL TO TRUCK TRANSFER OF PETROLEUM PRODUCTS.

ON THE BOTTOM PHOTO A TYPICAL RAIL TO ROAD SUPPLY TRANSLOADING AND STORAGE AREA IS SHOWN. A LORRY TRAIN APPROXIMATELY THREE-FOURTHS EMPTY IS STANDING ON THE TRACK AND IS PROBABLE IN PROCESS OF BEING OFF LOADED. SMALL

VARIOUS SIZE CRATES HAVE BEEN STACKED ON BOTH SIDES OF THE RAIL LINE.

ALTHOUGH NOT SHOWN ON GRAPHIC THREE CARGO TRUCKS ARE BEING LOADED WITH
CRATES FROM THE STACKS.
